1980

**EDGEMONT AND EAST DURHAM
EARLY TEXTILE MILL VILLAGES**

DURHAM, N. C.

Report produced by the Historic Preservation Technology Class
of 1978-1979
Durham Technical Institute

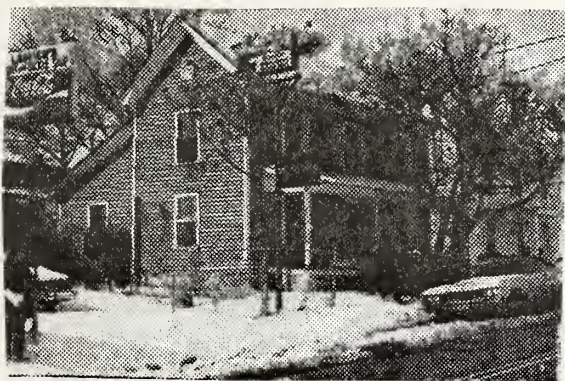
151. 1304, 1306 Angier Avenue. Ca. 1893

These two-story gable end houses with rear sheds, apparently superintendents' houses or rooming houses for the Commonwealth Cotton Mill, have double rear interior chimneys, central front doors flanked by 6/6 windows. 1306 has a simple one story full facade porch (probably original) while 1304 has a one-story central bay modern porch. These houses are a fairly common size and style in Edgemont. Though both are in relatively good shape 1306 shows more care.

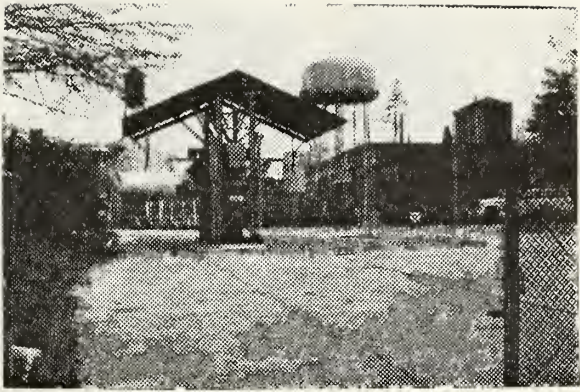
154. 1400,1404 Angier Avenue.

An oil distributing complex made up of two major buildings: a five bay garage and a four bay office/warehouse; a smaller building behind the office, and several oil storage tanks and pumping equipment. All of the buildings have concrete post and lintel construction with brick infill typical of the period in which they were built.

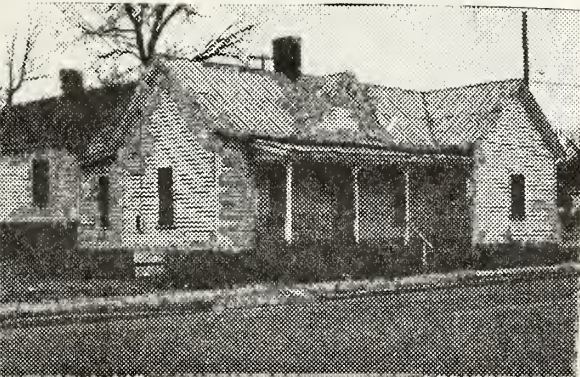
156. 1502 Angier Avenue. Pre-1913

This house is essentially the same as above except that it has an additional bay on the facade which at one time served as a store.

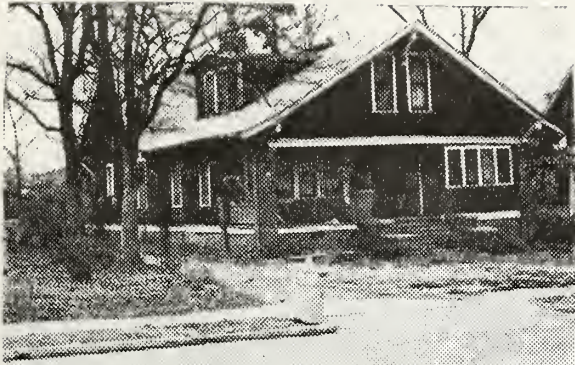
158. 1604 Angier Avenue. 1913-1937
One-and-a-half story bungalow, apparently originally a duplex, with several chimneys, front, rear and side gables and dormers on the sides and rear. It has side by side front doors with triple windows. This style although not extremely common can be found spotted throughout the neighborhood.

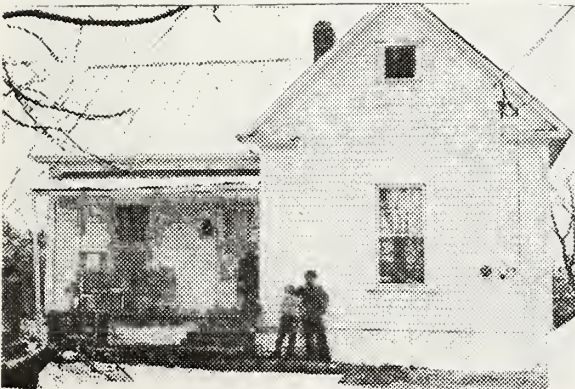
160. 1606½ Angier Avenue. 1913-1937 (according to map, possibly older, moved to this location)
One-story single family, "L" shaped house with double vertical pane door and front, 6/6 windows. Shed roof porch in the "L." Centrally located interior chimney. The side windows are 6/9 (Federal style). The building appears to be a very simple Greek Revival farmhouse which does not show on the 1913 Sanborn map in this location which indicates it was moved to this site. Excellent condition.

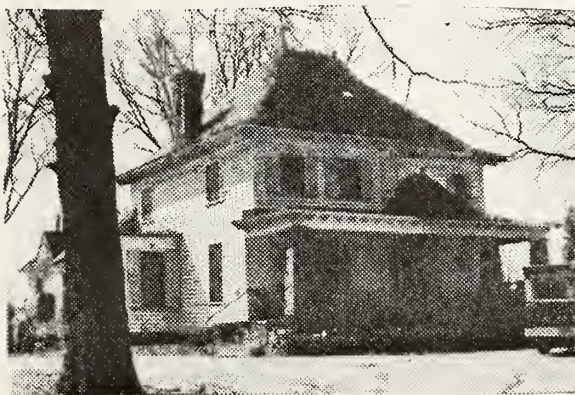
161. 1612 Angier Avenue. Pre-1913
Large two-story single family, Italianate-Queen Anne style house with bell cast hip roof (topped with cresting), one side interior and two rear exterior chimneys with decorative corbeling, central front door with 4 pane side light flanked by a tiny window on the west side and a double 4/4 window in a projecting bay on the east side. One-story full replacement facade porch with bell cast hip roof over the entrance bay. The house sits far back from the street on the crest of a knoll, surrounded by old trees, and is unique to the neighborhood. All door and window surrounds are topped by distinctive cur-

vilinear bosses with a central raised bull's eye pattern. The eaves on the main block of the house have Italianate brackets while the false gable in the east side of rear wing supports a complex sawnwork pattern. House is in generally good condition.

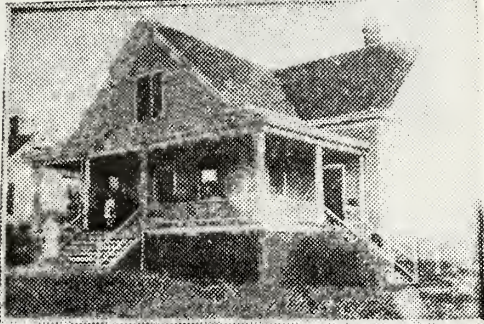
166. 1800 Angier Avenue. Pre-1913, Post-1937 facade.
Contemporary two story brick Colonial Revival funeral home overbuilt around a one-and-a-half story single family frame, Victorian house with some stylistic pretention. Only visible remains of the original house is the interior staircase.

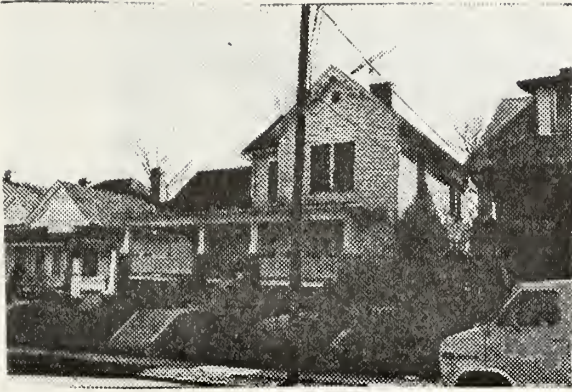
169. 1810 Angier Avenue. Pre-1913
 A three bay, two-story "L" shaped house with a one-story gable wing at the Southern end of the facade. A porch with frame posts on brick pedestals supporting a heavy lintel and hip roof. Scroll work bargeboard decorates the front and south facing gables, adding interest to the top of this well kept home.

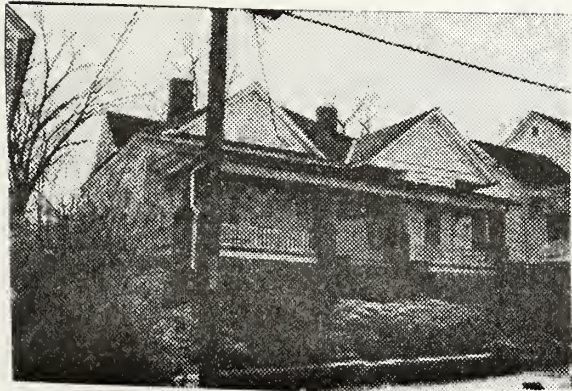
170. 1900 Angier Avenue. Pre-1913
 One-story German sided frame single family house. High deck on hip roof, with staggered and pedimented projecting front bay. 1/1 sash windows with replacement front door. Attached front porch probably not original; bungalow style brick posts and wooden turned balusters. Good condition.

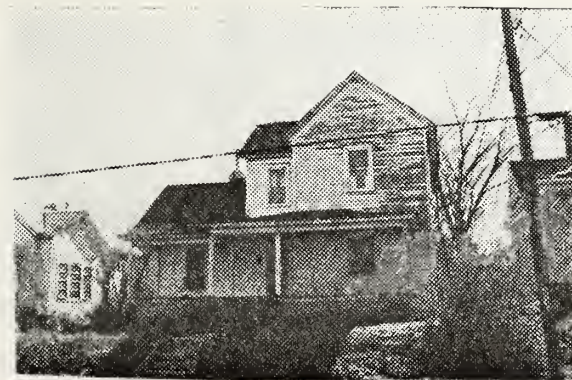
171. 1902 Angier Avenue. Pre-1913
 Two story, "L" shaped frame single story, one family, German sided house with projecting right bay capped by a gable. 1/1 sash windows, glazed and paneled front door. Attached hip roofed wrap-around porch supported by wooden Doric columns. In fair condition.

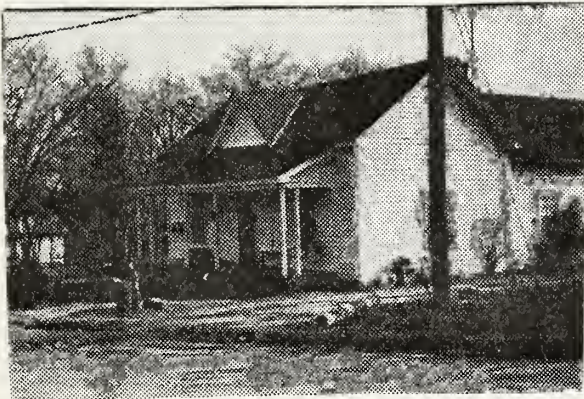
174. 1410 Cross Street. Pre-1913
One-story single family "triple A" mill house with central chimney, central door flanked by 4/1 under a shed roof full facade porch. A very common house style and size, in very good condition.

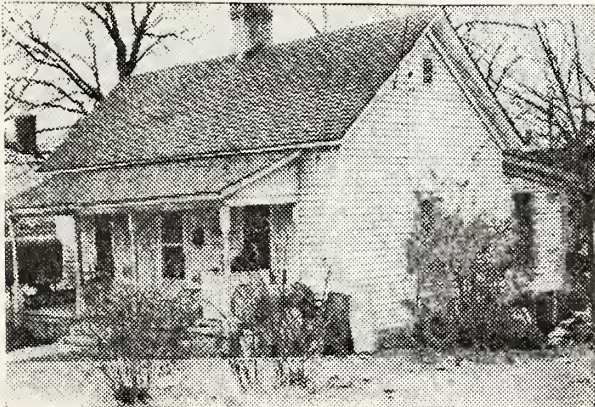
175. 203 South Goley Street. Pre-1913
One-story single family side gable mill house with central chimney, central door flanked by 4/4 windows under a full facade shed roof porch with turned posts. Style and size common to neighborhood. In good condition with much original fabric.

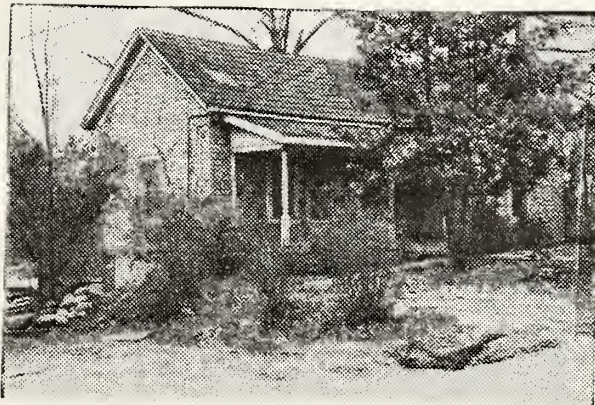
176. 205 South Goley Street. Pre-1913
Single story, single family, "L" shaped house with gable roof, central chimney. Replacement front door in "L" corner, double 2/2 windows in north bay, single 2/2 window in projecting south bay, front shed roof porch with turned posts. Style and size common to neighborhood and in fair shape.

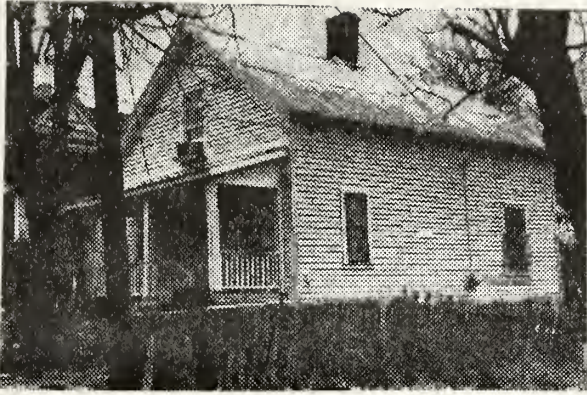
177. 206 South Goley Street. Pre-1913
One-and-a-half story, single family, front gable mill house with central chimney, front door on north side and 2/2 window on south side under full facade shed roofed porch, central 4/4 window in gable. House while not unique is not common in the neighborhood and is in fair condition.

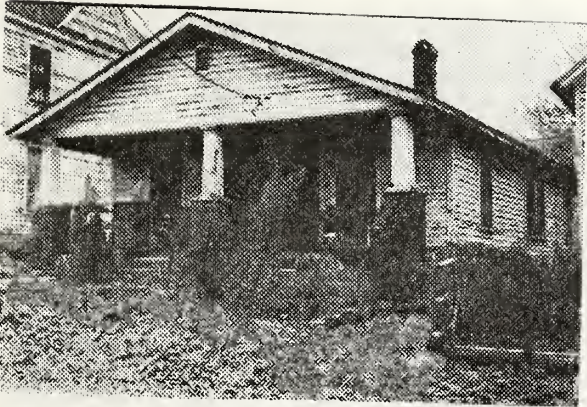
178. 208 South Goley Street. 1913-1937
One-story duplex front gable mill house with two interior chimneys, two central 15 pane glass doors flanked by 4/4 windows under an engaged porch. Not unique but not common, in fair shape.

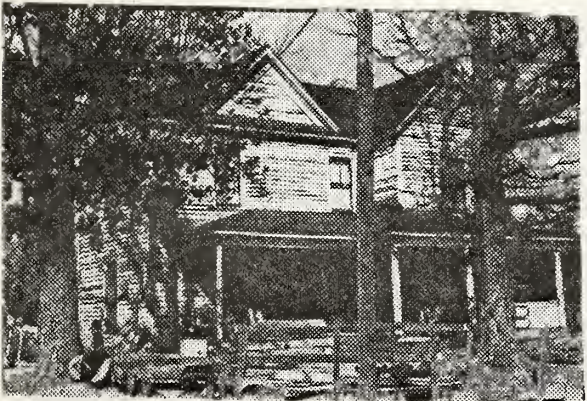
179. 210 South Goley Street. Pre-1913
Large two-story, "T" shaped house with gabled roof with two interior chimneys and a front door with side light flanked by 4/4 windows. Single story full facade porch with hip roof. Its size sets it apart. Poor condition.

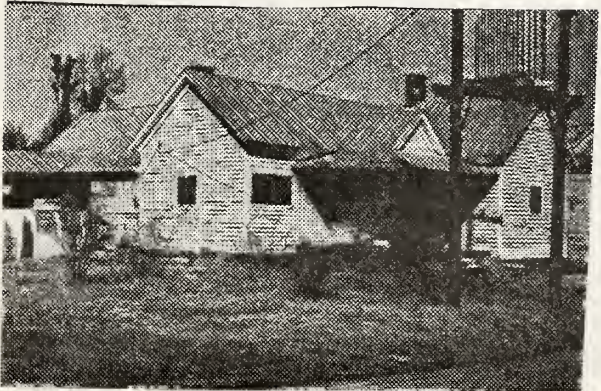
180. 212 South Goley Street. Pre-1913
One-story, single family, "L" shaped house with two interior chimneys, central door in "L" corner. House style is common but very little of original fabric remains (replacement windows, porch posts etc.). Now used commercially.

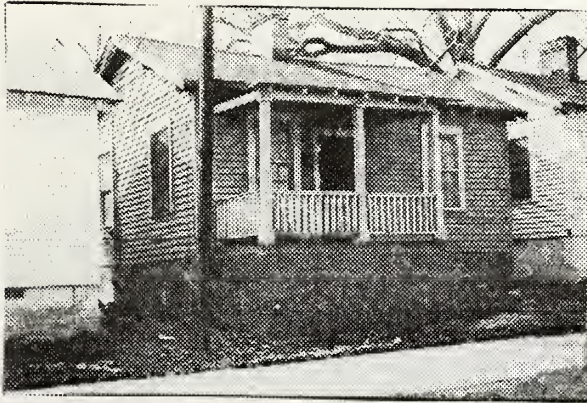
182. 1304,1306,1308,1310,1312,1314 South Holman Place. 1913-1937
A group of six small, single family one-story side gable mill houses with central chimneys, central door flanked by 6/6 windows, all with small apparently original porches. All are in moderately good condition (1312 is in fine shape) and 1314 is being used as Pentecostal Holiness Church. Perhaps mill housing for nearby Morven Cotton Mill, organized in 1922.

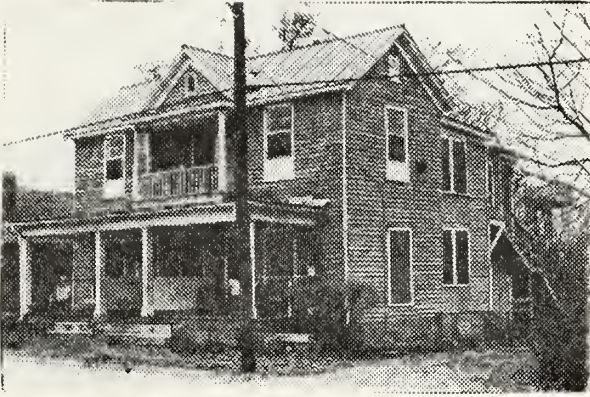
185. 300 South Plum Street. 1913-1937
Two-story single family (originally, now triplex) "triple A" with three interior chimneys, three front doors (two added later) and two 4/4 windows under full facade, one-story porch which supports partially engaged central bay balcony. 2nd story windows have apron-like exterior treatment. There are arched vent windows in attic in three gables. House has been substantially enlarged with at least three additions in rear. Similar in size and style to others in neighborhood but with more decorative elements. Fair shape.

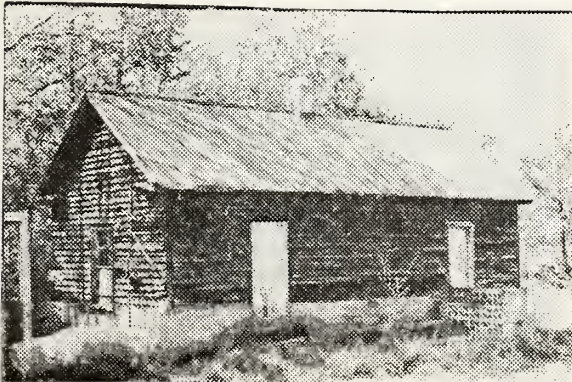
188. Vale Street Extension. Probably Pre-1913
Center of block or alley between South Plum and Cross Street. One-story gabled end building, probably originally a small house which was moved to this site. Central chimney now cement block. What is now the rear has central door flanked by 6/6 windows (this was probably the original front). The present front now has two cross and bible doors which appear to be from some other building.

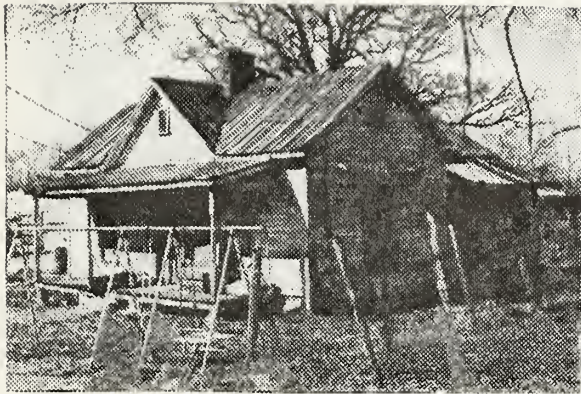
189. 1601 Vale Street. 1913-1937
One-story single family "triple A" with central chimney with central paneled door flanked by 2/2 windows under full facade shed roof porch with turned posts. Common size and style. At the dead end of a street the house still retains its privacy but unfortunately has a cement plant on its west side and is in poor shape.

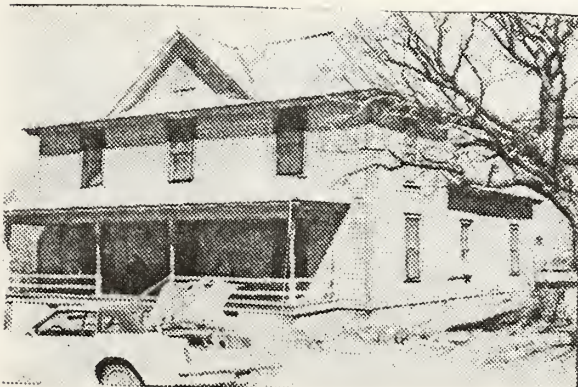
192. 1705 Vale Street. 1913-1937
Large two-story single family house (possibly boarding house), hip roof, rear interior and exterior chimneys. Central paneled two light door flanked by 4/4 windows under hip roof full facade porch with original turned posts. Good condition.

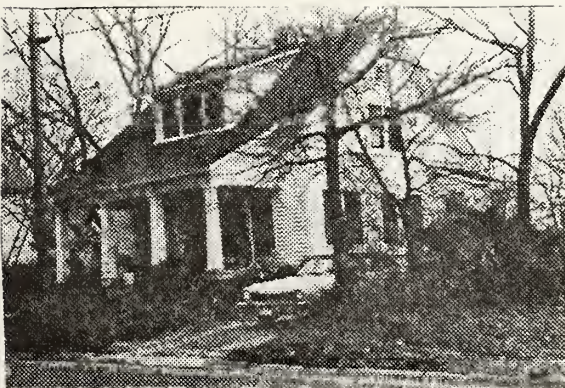
196. 1804 Vale Street. 1905-1913
One-and-a-half story one family cat slide house with Dutch dormer in front and rear, two interior chimneys. Central front door with 9 lights flanked by double 12/1 windows to west to 1 to east, all under full facade attached shed roof porch. Good condition Colonial Revival style unusual to neighborhood.

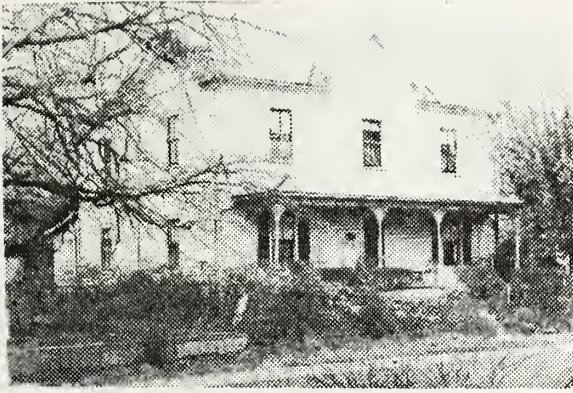
197. 1805 Vale Street. Pre-1913
Two-story single family, "triple A" with two central chimneys. Central door with large light flanked by 2/2 windows under a full facade hip roof porch with turned posts and sawnwork brackets. Similar sawnwork can be seen in front gable. Apparently built in mid 19th century. Evidence of this include late Greek Revival interior doors and indication of original exterior end chimney. This house was known as the Cheek Farm which records show was subdivided in 1905.

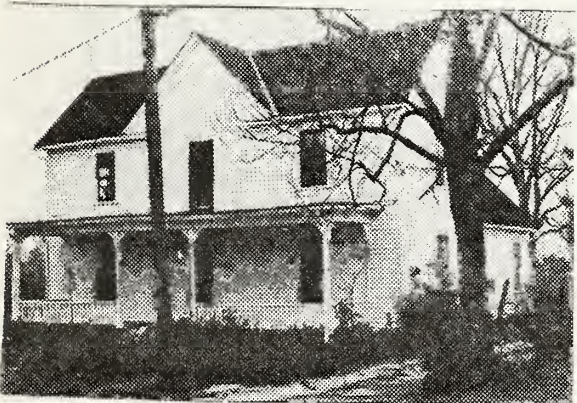
199. 1808, 1809, 1810, 1817 Vale Street and 402 Clay Street. (Corner of Vale). 1905-1913
A group of two-story single family gabled houses (some T's, some L's, and one "triple A"), with interior chimneys with central doors flanked by a 2/2 window sash on each side under one-story hip roofed full facade porches. These houses are all large and would also fit in a rural setting. 1808 and 1810 preserve the most original fabric. 1808, 1810 have original turned porch posts with brackets, 402 Clay Street has original Doric porch columns.

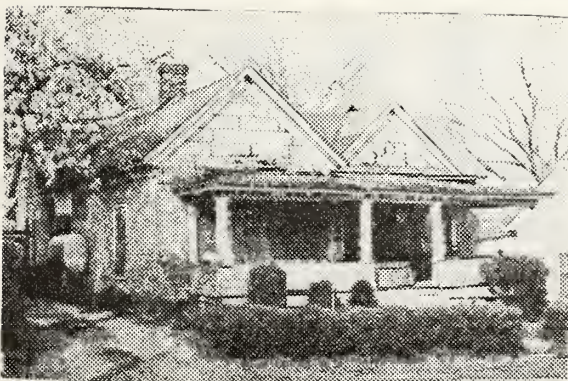
200. 1811 Vale Street. Pre-1913
One-story single family multi-gabled house with central interior chimney. Central front door in "L" formed by projecting bay flanked by 2/2 windows under full facade hip roofed porch with replacement posts. Condition poor.

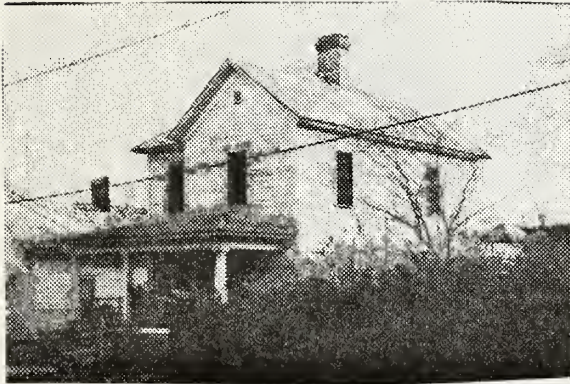
202. 1814 Vale Street. 1913-1937
Two-story single family house with high hip roof with front and rear projecting gabled bays and one central chimney. Front door nestles in "L" with 6/6 windows in projecting bay in the west. Simple hip roof porch with original well-proportioned Doric posts. Poor condition.

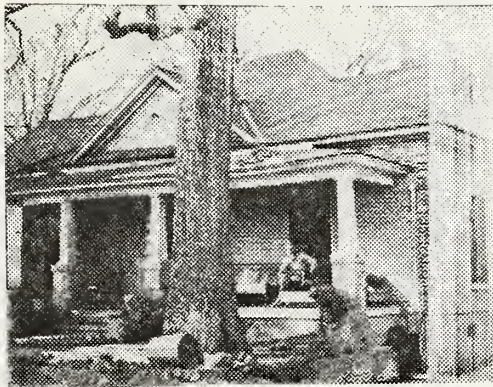
203. 1815 Vale Street. Pre-1913
One-story single family house with high hip roof with front, side and rear gabled bays. (From front it appears to be "triple A"). Central door with 1/1 window in bay to east. Replacement front porch with enclosed west bay. House has been brick veneered leaving little original fabric visible.

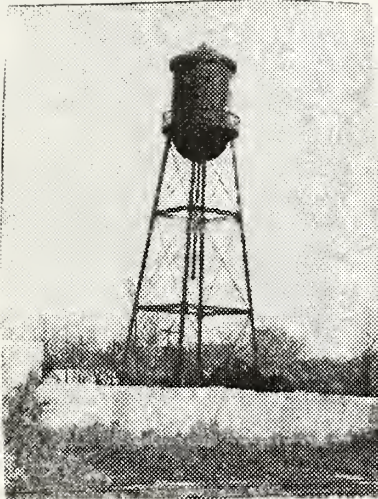
206. Newport Lumber Company Water Tank. North Side of Rail Road Tracks Between South Holman and South Goley Street. Pre-1913
 A cylindrical water tank with conical top and hemispherical bottom supported by steel trusses. A significant early water tower which formerly was part of Newport Lumber Company.

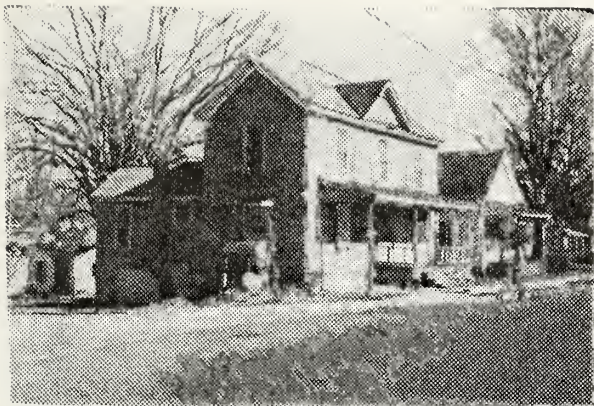
208. 1401 Angier Avenue. Pre-1913
Two-story single family "triple A" I-house with interior rear chimney, center door, 4/4 windows with possibly original shutters on 2nd floor, full facade shed with replacement posts. Although in poor shape house is significant as the largest house on the block and one of the few with twin gable rear wings in this area.

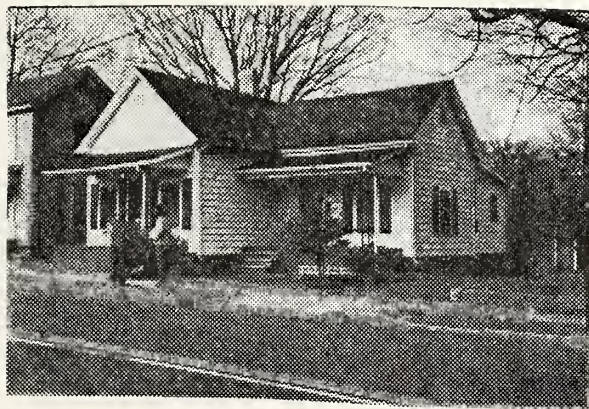
209. 1403 Angier Avenue. Pre-1913
One-story L-shaped frame store and dwelling combination. Front gable wing was once the store, and has a center door and replacement windows. Dwelling in side wing with a door and window. Each section has own shed porch. This house is in excellent condition and is unique in neighborhood.

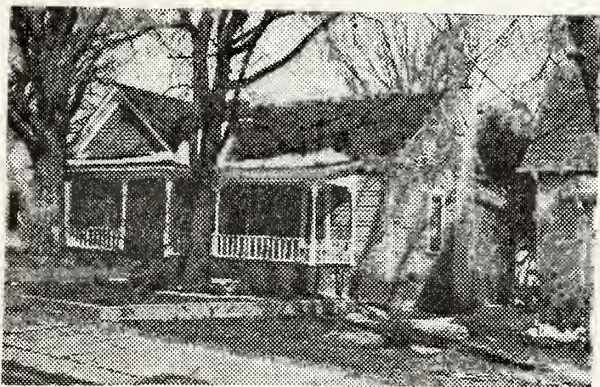
210. 1405 Angier Avenue. Pre-1913
One-story single family house with extending front gable end, 3 bays wide with center door, interior chimney and an original porch with turned bracketed posts that undulate along the full facade. House fits comfortably into the scale of the neighborhood. In very good shape and needs little or no work.

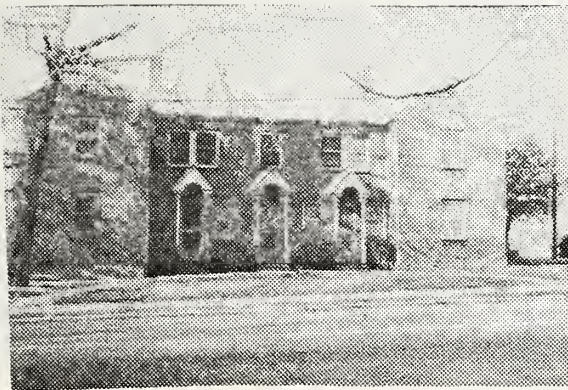
214. 1513 Angier Avenue. 1936
Two-story, 5 bay apartment building, H-shaped with front gabled end. The 3 center bays each contain an entrance with a small classical gable stoop. Only "modern" apartments in area, contrasting nicely with surroundings. Very good shape.

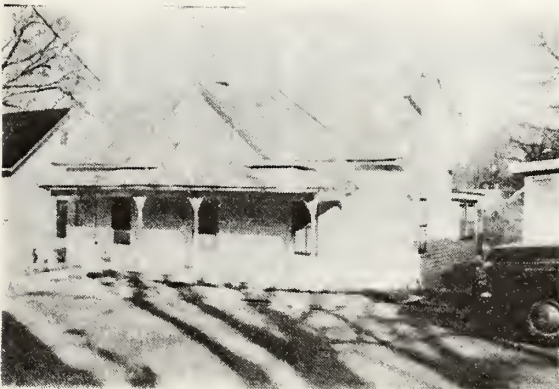
219. 104,106,108 North Blacknall. Pre-1913
Single story, single family "triple A" mill type houses. All probably L-shaped but have rear shed additions. All have 3 bay facades covered by a shed roof front porch, interior chimney. 106 is unique because the front gable is located on the left side of the facade.

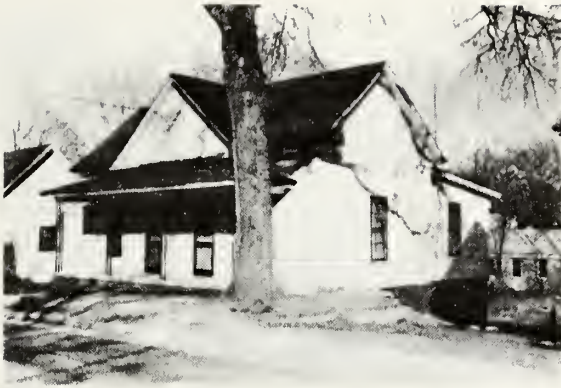
220. 103,105 South Blacknall. Pre-1913
 These two houses are nearly identical. Each is a one-story duplex "triple A" house with rear shed additions. Interior center chimney, tin roof, four bay facade (2 doors, 2 windows), covered by a full front porch with hip roof. 105 still has original front porch with turned posts.

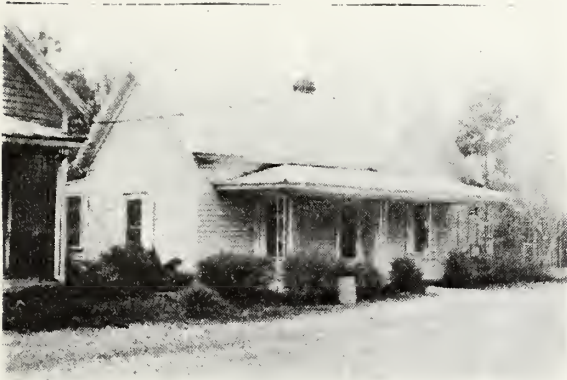
221. 1411 East Main, 103,105 North Goley.
 Pre-1913
 Single story single family dwelling with front projecting gable wing with additions making the general shape a U. 1411 and 105 are L-shaped. All have interior chimneys, three bay fronts with center doors and remodeled hip roof porches. Houses are the same material and were probably built by the same builder.

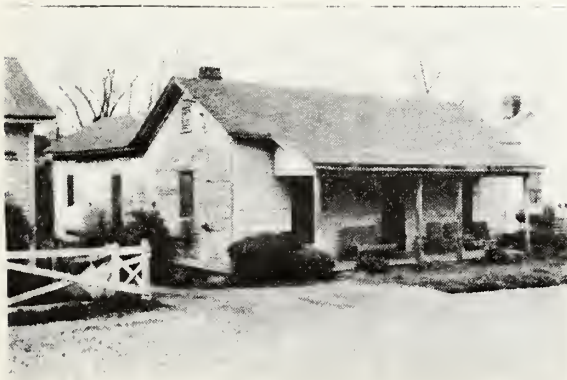
222. 107,115 North Goley, 1404,1406 Morning Glory, 110,118 North Blacknall. Circa 1915.
 Large group of single story single family plain, L-shaped mill houses, probably built for the Golden Belt Manufacturing Company. Each is three bays wide with center door, and shed roof over porch continuing the same line as main roof. 4/4 sash windows. Built at same time but have a few changes over the years. Generally in fair condition.

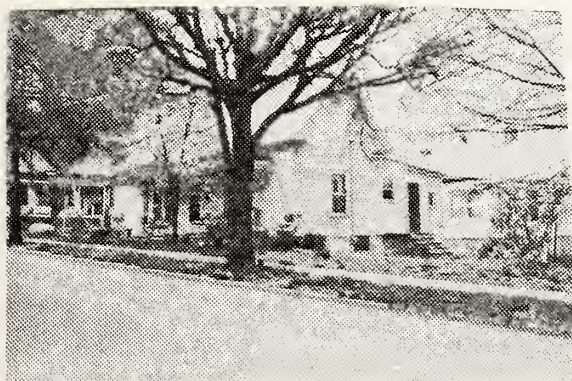
223. 1401 East Main Street. Pre-1913
 One-story "triple A", frame center hall plan, single family dwelling. Full width hip roofed porch with replacement posts. 2/1 windows, replacement front door. Corner site, and was probably one of the first houses on the block. Good condition. Typical of neighborhood.

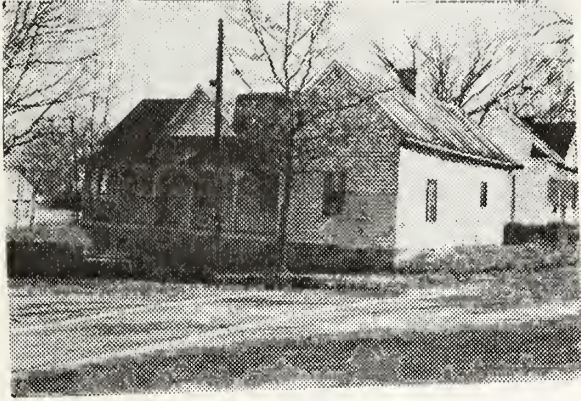
224. 1402 East Main Street. Pre-1913
5 bay, one-story house with 4 bays sheltered by a shed porch and the 5th bay in cross gable end. Standing seam roof, 6/6 windows, some original posts and sawnwork, and a false gable centered over porch. This house fits the general scale and style of its neighborhood. Good condition.

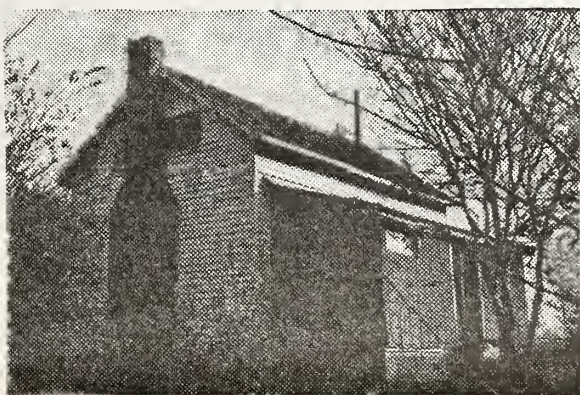
Possibly the oldest surviving houses in the mill village. Both houses are 3 bay 1½ story frame structures which originally had exterior end chimneys with stepped shoulders, and one-to-five common bond.

Only 511 has survived in recognizable form. This house retains 6 inch wide heart pine flooring, and has an unusual 9 light upper story window hung as a casement. The entire interior has been gutted.

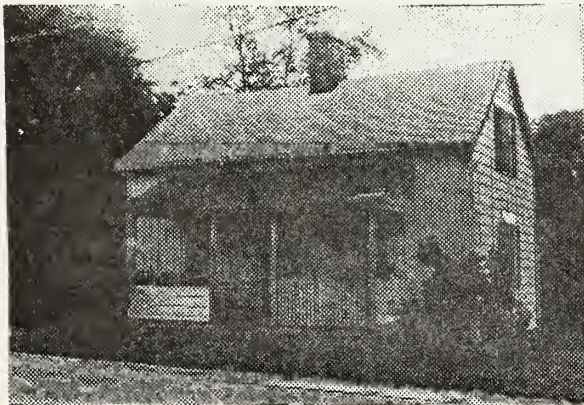
611 Reservoir Street.

This mill house type is a strongly vertical, gable-roofed, 1½ story single family house with molded board-and batten, original 4/4 or replacement 6/6 sash, raised 4-panel doors, central chimney, front shed porch probably once with chamfered posts, and rear shed or ell wing. The shed roofs create an interesting variation on the saltbox silhouette. Each house has a small entrance hall which opens into a narrow beaded pine sheathed room on either side.

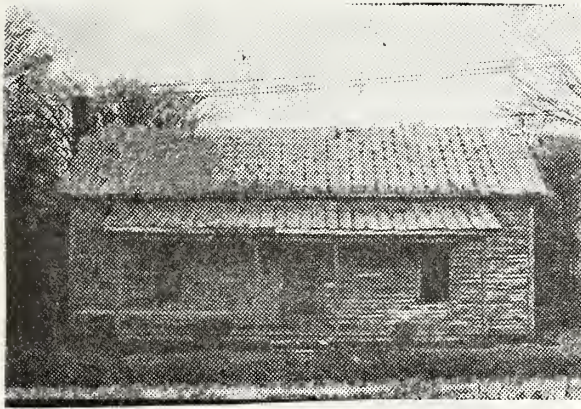
507 Scoggins Avenue. Pre-1913
Simple, nicely detailed, 1 story frame house with elongated 3 bay facade and center hall plan. Incorporates elements of earlier Greek Revival with contemporary Victorian period styling. Notable characteristics include one of earlier pair of free standing single shoulder, stepped base, exterior end chimneys, 2-light transom over replacement raised 4-panel doors, random width porch ceiling boards, raised 2-panel interior doors, simple chamfered and beaded mantels, wide heart-pine floorboards, and wide flush sheathing in rear ell. Believed to be farmhouse predating or contemporary with Durham Cotton Manufacturing Company.

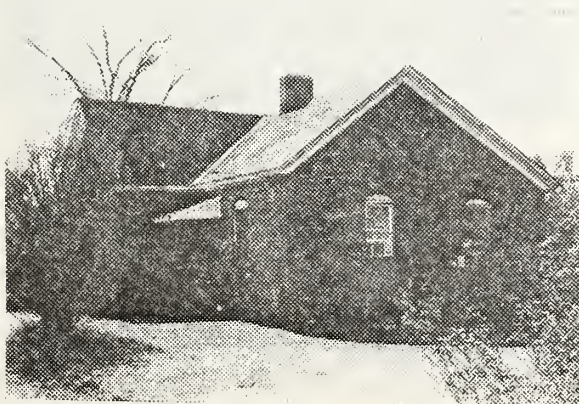
506 Harnett Street. Pre-1913
Standing on a lot formerly occupied by a small commercial complex, this pre-1913, one story, L-shaped, gable structure is the only original brick house within the district and one of two in the entire Edgemont-East Durham area surveyed. Pierced by segmently arched window and door openings, the walls are laid in 1/5 American bond with traces of white paint used to highlight the mortor joints remaining. Patterned tin shingles cover the gables which were once bridged by a corner porch. The interior has been remodeled but wide mouldings remain. Two diagonal hearths and a parlor also remain and are served by the central chimney of this

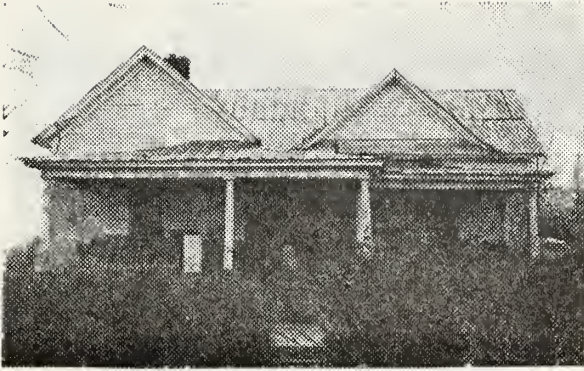
614 Scoggins Avenue. Pre-1913

Single story, frame house with picturesque massing. Primary focus on full facade hip-roofed porch with classical columns and wide moulded cornice. Somewhat altered interior and exterior, however, both form and detail give this house a relative degree of distinction within the context of the standard mill housing of the surrounding area.

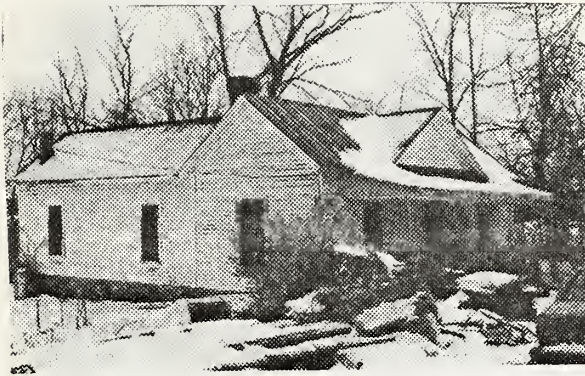
613 Harnett Street. Pre-1937

Isolated at the end of a small dirt lane is this 1 story, L-shaped "triple A" frame dwelling. It has the fairly typical features of mill housing: German siding, 6/6 sash windows, plain detailing and narrow board interior sheathing. Notable for the district, however, is the unique location of the corbelled interior chimney.

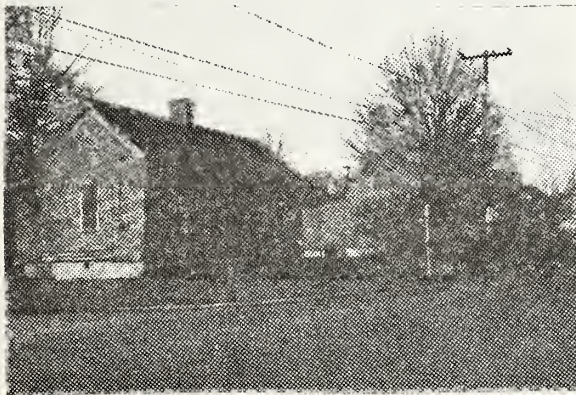
508-512 Bacon Street, 1705 Gillette Street. Group of three identically built, 1 story, 4 bay frame mill houses remain of the original four on Bacon Street. Unlike the normal door spacing of the Gillette Street house, these doors were placed within 3' of one another, one now filled in on each house. 1705 Gillette Street is the only example remaining of the original five once wrapping the corner of Gillette and Bernice Streets. Each house has paired front doors, narrow 4/4 sash windows, and originally had a full facade shed porch, removed when the street was widened.

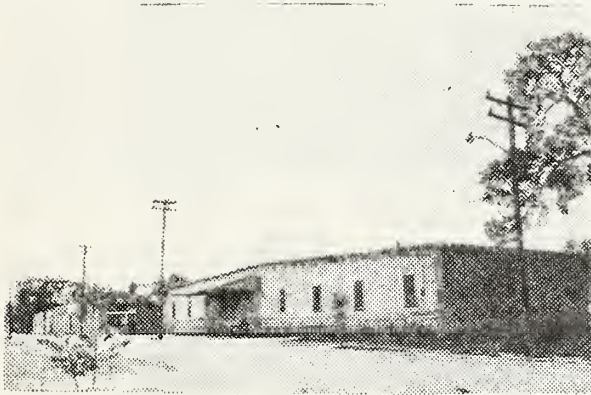
Typical example of early 20th century tobacco factory/storage facilities, it is one story in height with broad, very low pitched gable roof, frame walls covered with tin, and 6/6 wooden sash windows. Office area in original factory had brick walls only on street facade, randomly laid in American bond ranging from 4/1 to 15/1. Though doubled in size by present manufacturing concern, the original fabric is basically intact including massive pine posts and chamfered beams in interior.

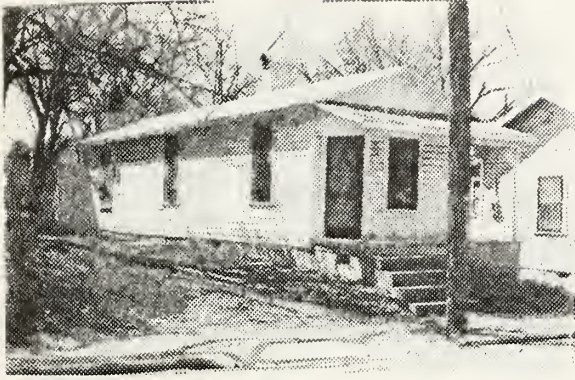
1506 Pettigrew Street. 1913-1937

A plain, 3 room shotgun house with front gable to street, simple door and window surrounds, 4/4 sash windows, horizontal panel door, wide interior mouldings, and a pleasant mantel. 303 Sowell is similar, with the exception of a recessed porch under a hip roof.

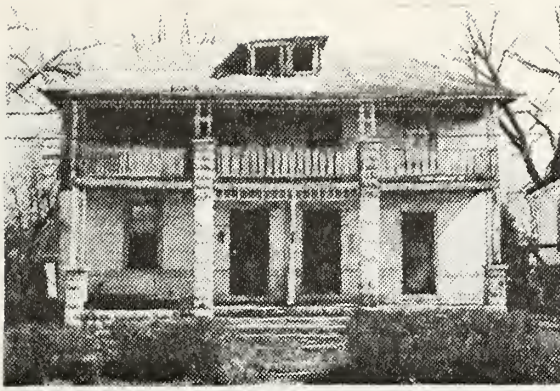
307 Sowell Street. 1913-1937

A 2 story, full facade veranda featuring assymetrical porch tiers, with tall columns to center instead of sides, dominates the first in a series of houses built by the Sowells in cast concrete blocks. A shed dormer lights the hip roof while 4/4 sash windows and 9 light doors, each with plain surrounds, pierce the smooth walls. A decorative string course of rusticated cast stone encircles the building, positioned beneath the windows rather than corresponding to interior floor height. Originally constructed as a multi-family investment property. A recent fire damaged upstairs of main block. Although not believed to be too serious, it caused the house to be vacated approximately 5 years ago and it since fallen victim to neglect and possible vandalism. Interesting as an example of block vernacular architecture built in the early 1930's and said to have been the first concrete block house built in Durham.

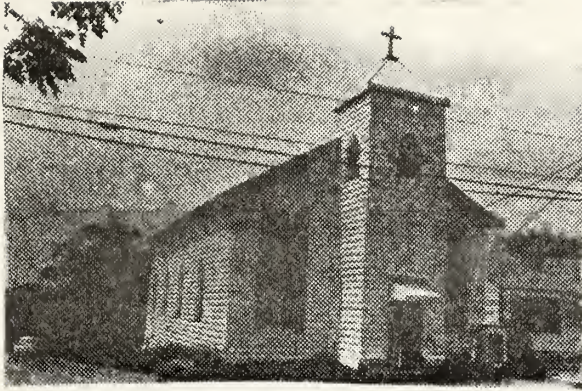
1410 Gillette Street. 1913-1937

True Way Holiness Church, formerly Ebenezer Baptist, is a simple rectangular cast stone church which replaced earlier wooden church on the same site at the corner of Gillette and Sowell Streets. The facade is dominated by a pyramidally roofed bell tower, rising above the end gable, flanked by two massive colored glass windows, and containing main entrance. The remodelled interior is also lighted by four pointed arch windows along each side. Built with block produced by Bishop James Sowell who was also the pastor at that time.

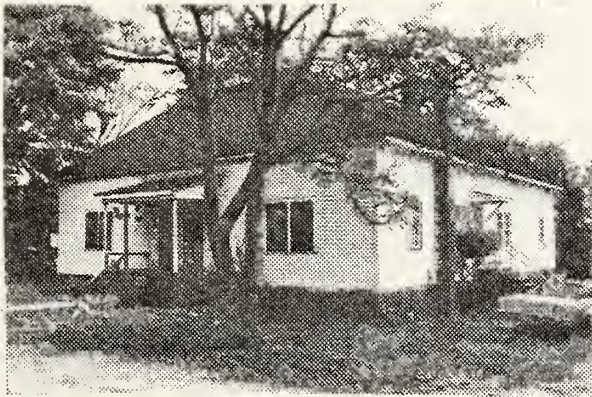
417 Sowell Street (Formerly East Durham Colored School). 1913-1937

This large remodelled one story building with hip roof, 6/6 sash windows, plain surrounds, and German siding, now serves as a duplex apartment. Originally it was the East Durham Colored School. Containing four classrooms and one office area, it accommodated grades 1-8 until 1939 when it was replaced by the newly constructed Burwell School at the end of the street.
